**Report No. NA-70-23**  
**(DS-70-2)**

# **ACCELERATED TESTING OF GENERAL AVIATION ENGINE EXHAUST SYSTEMS**

**DEPARTMENT OF TRANSPORTATION  
FEDERAL AVIATION ADMINISTRATION  
National Aviation Facilities Experimental Center  
Atlantic City, New Jersey 08405**

Prepared by:  
GERALD SLUSHER

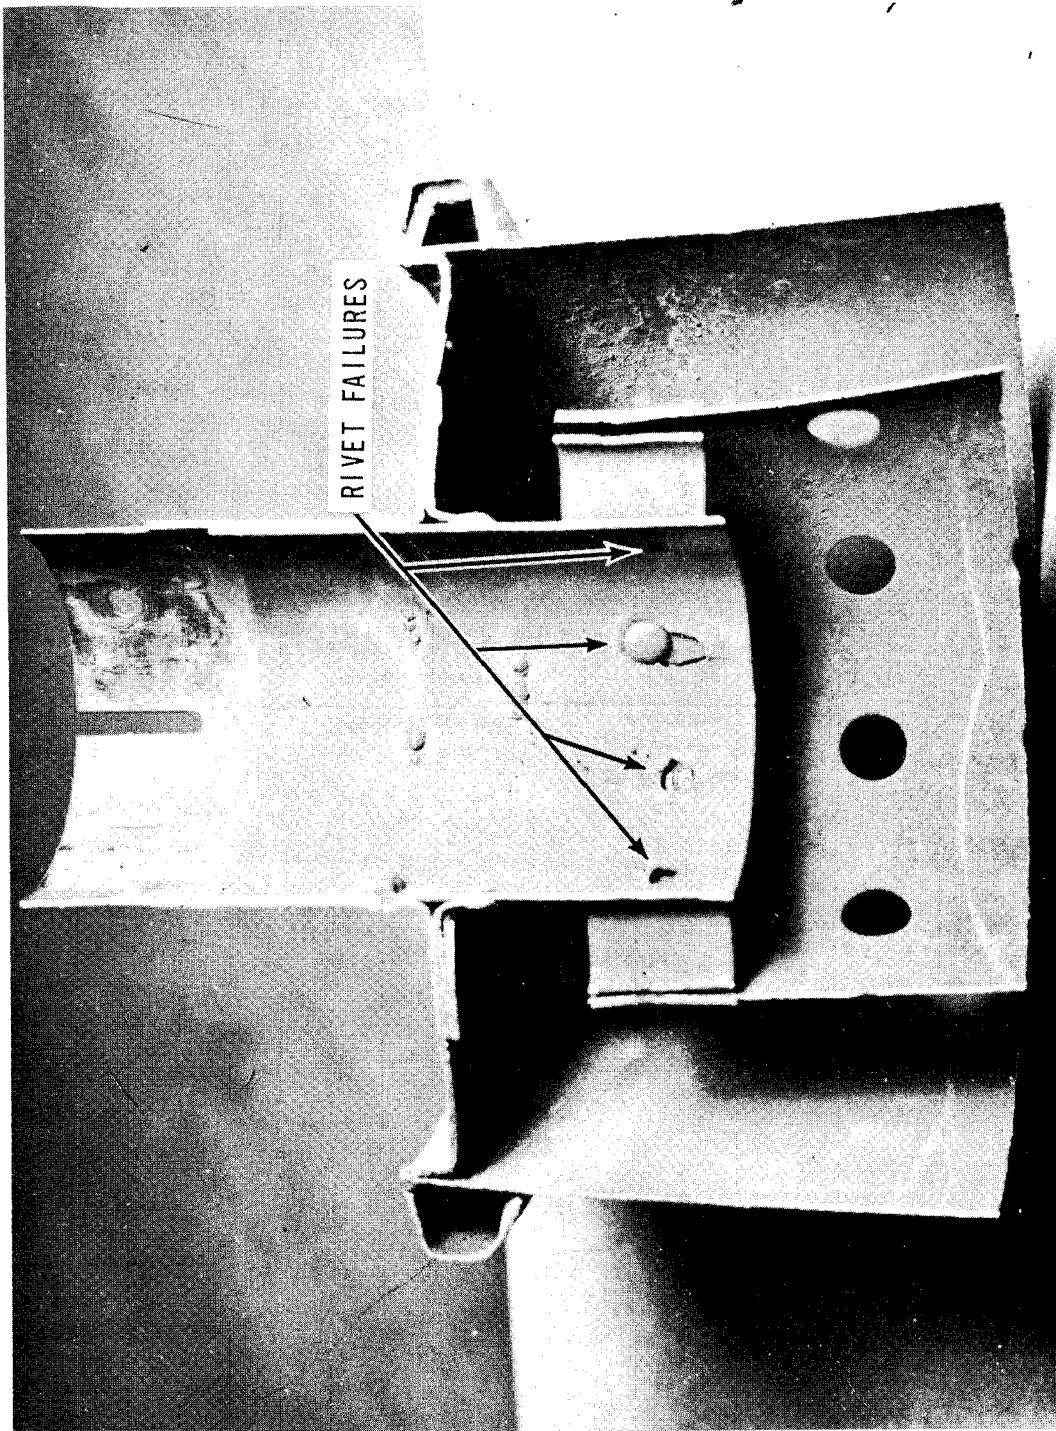
Test Hours - 448: A crack occurred along the radius of a muffler end plate at 448 test hours as shown in Figure 1.8. Three of four rivets joining the baffle tube to the end plate intake tube were completely sheared and the fourth, while still intact, was cracked and weakened by loss of material. This is shown in Figure 1.9. Metallographic examination is discussed under the subheading of Sample No. 7, and the defects are shown including the rivet failure in Figures 26 through 28 of Reference 5. Material was AISI 347 stainless steel. The baffle tube operated at temperature levels of 1500°F to 1600°F maximum, and the end plate operated at 1000°F to 1200°F maximum temperature, as determined in Reference 4.

FIG. 1.9 FAILED BAFFLE TUBE RIVETS, MUFFLER
